INFRARED
PREVENTIVE MAINTENANCE SURVEY
For
CORE POWER/SCIENTIFIC GAMES
SHARON HILL, PA

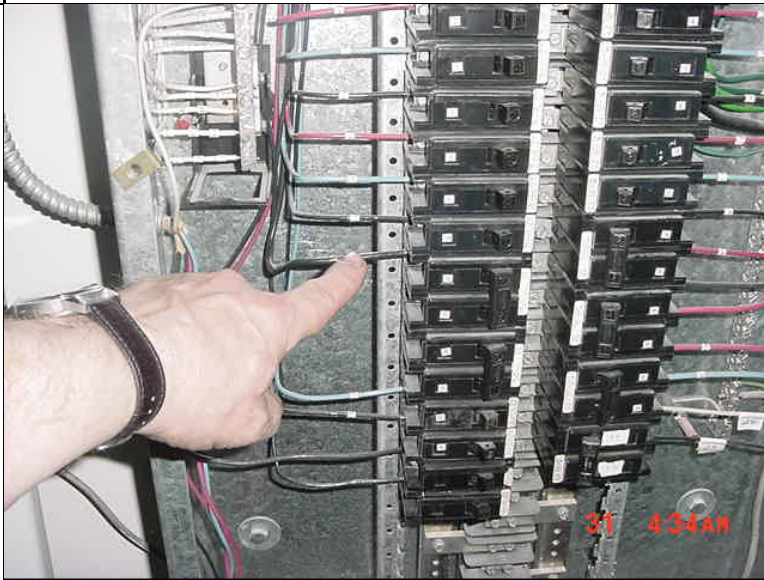
Problem #: 2

Main Electrical Room Near Auto Transfer Switch

Panel LP-1 Circuit Breaker 13

32°C. 4°C rise on load side. 28°C on conductor with same load. 24°C ambient temperature.

Tightened. Probably OK. 60% load.

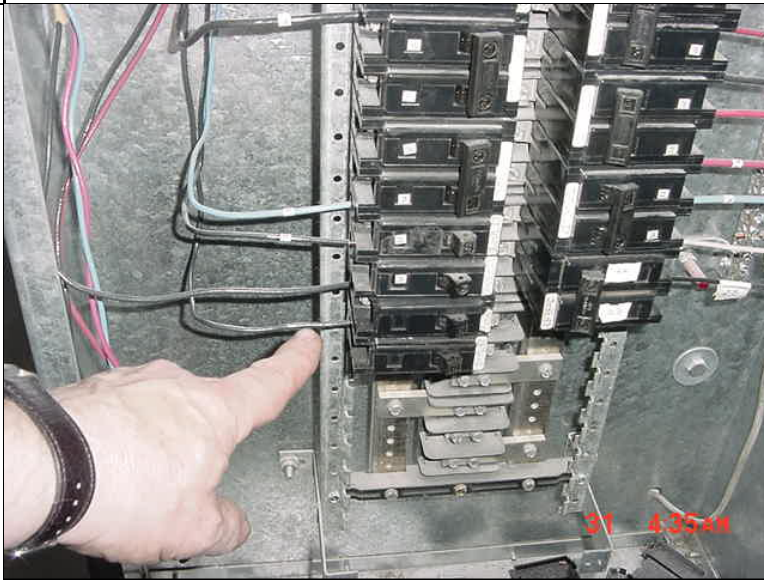
Problem #: 3 DATE: January 31, 2006

MVC #: 283 IR #: 0131-03
LOCATION
Main Electrical Room Near Auto Transfer Switch

EQUIPMENT
Panel LP1 Circuit Breaker #29

PROBLEM
31°C. 4°C rise on load side. 27°C on conductor with same load. 24°C ambient temperature.

COMMENTS / RECOMMENDATION
Tightened. Slightly loose. Same temperature. Probably OK. 60% load.

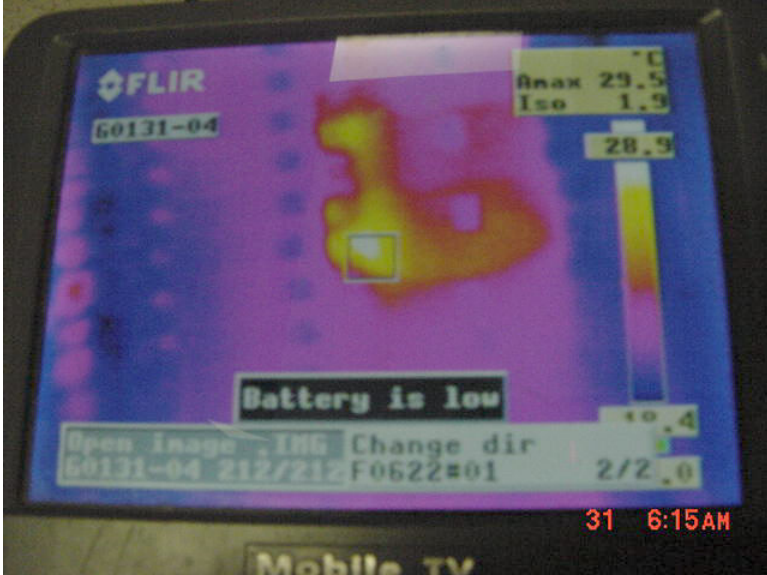
Problem #: 5 DATE: January 31, 2006

LOCATION
Computer Room

EQUIPMENT
PDU, Panel 1, Breaker 20 Load Side

PROBLEM
30°C. 9°C rise on line side of double pole breaker (plug in). 21°C on conductor with same load. 18°C ambient temperature.

COMMENTS / RECOMMENDATION
Replace 2 pole 30 plug in. Could be upgraded to bolt in.
