INFRARED
PREVENTIVE MAINTENANCE SURVEY
For
CORE POWER/SCIENTIFIC GAMES
SHARON HILL, PA

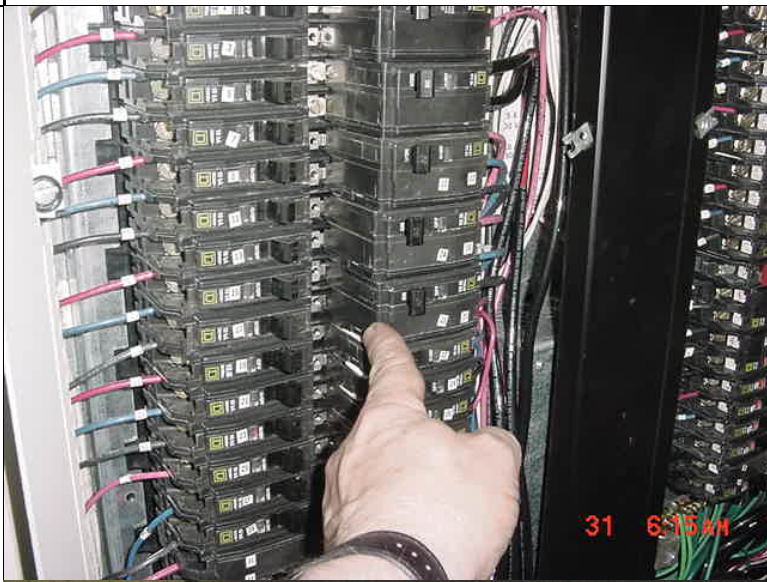
Problem #: 3 DATE: January 31, 2006

EQUIPMENT
Panel LP1 Circuit Breaker #29

PROBLEM
31°C. 4°C rise on load side. 27°C on conductor with same load. 24°C ambient temperature.

COMMENTS / RECOMMENDATION
Tightened. Slightly loose. Same temperature. Probably OK. 60% load.
